Danish investigations on accidents with heavy vehicles and cyclists

Anne Eriksson, Danish Road Directorate
Volvo Workshop Gothenburg
November 8th 2017

Right turn accidents between heavy vehicles and bicycles

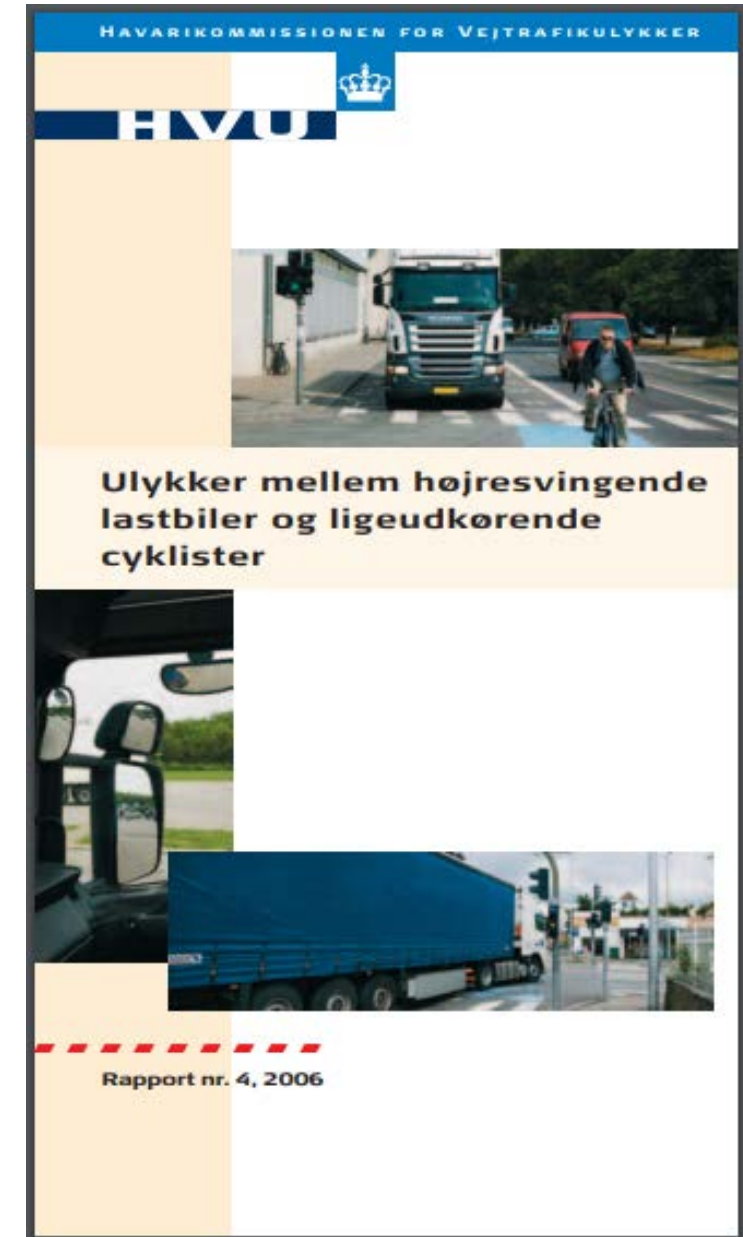
Direct vision is limited from cabin with typical design

- 25 accidents with killed or seriously injured cyclists
- Unsuccessful look out for cyclists was an accident factor in all 25 accidents
- Findings have led to:
 - More focus on use of mirrors
 - Proposal in EU for better direct vision from truck cabins

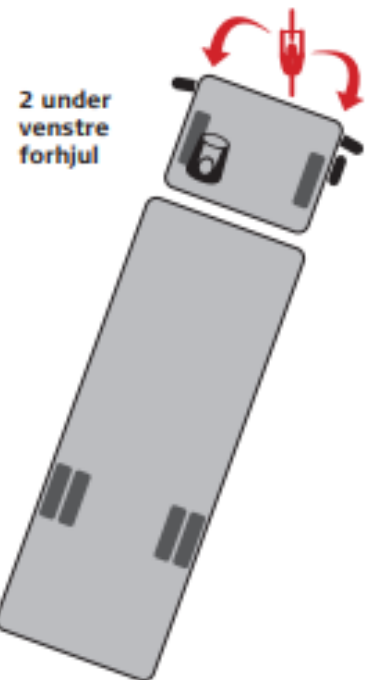
2 cyklister rammes af lastbilens front

16 cyclists were run over by truck: Their position before being hit

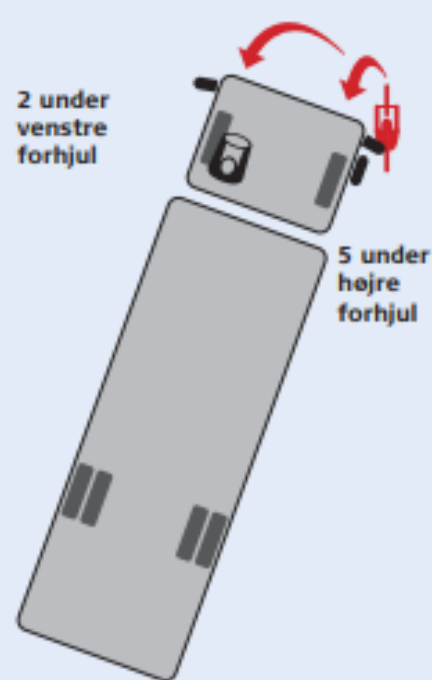
7 cyklister rammes af lastbilens højre forhjørne

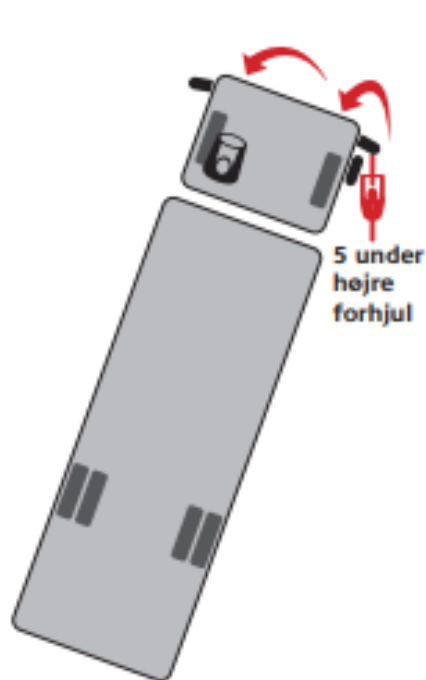
5 cyklister rammes af lastbilens førerhus i højre side

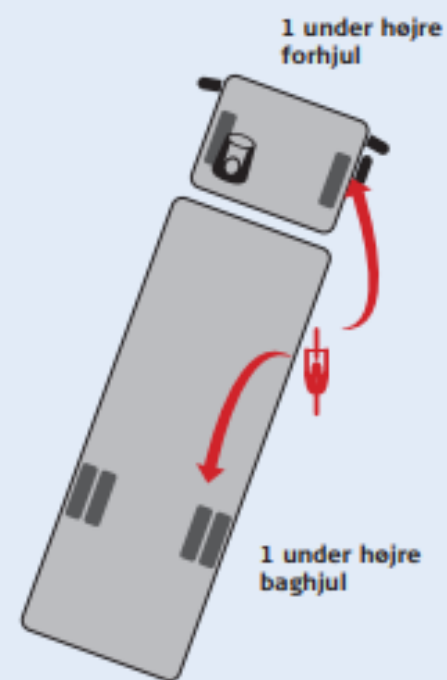
2 cyklister rammes af lastbilens højre side bag førerhuset

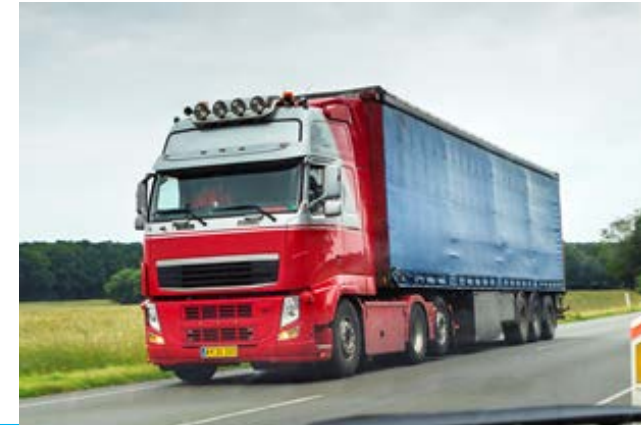
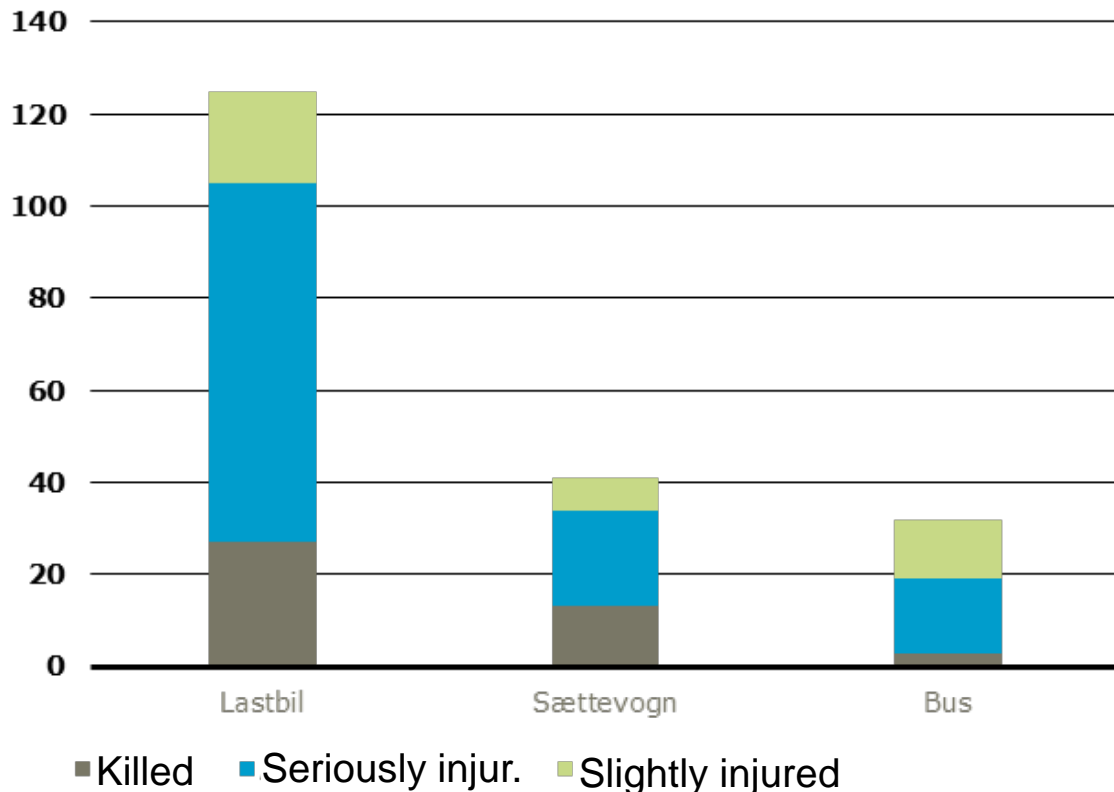
Right turn accidents 2006 – 2015

- Accidents with road tractor for semi trailers were the most serious

Lorry	Road tractor	Bus	Total
No accidents	124 (64%)	41 (21%)	30 (15%)	195
	Lorry	Road tractor	Bus	Total
Killed	27	13	3	43
Seriously injured	78	21	16	115
Slightly injured	20	7	13	40
Killed and injured in total	125	41	32	198

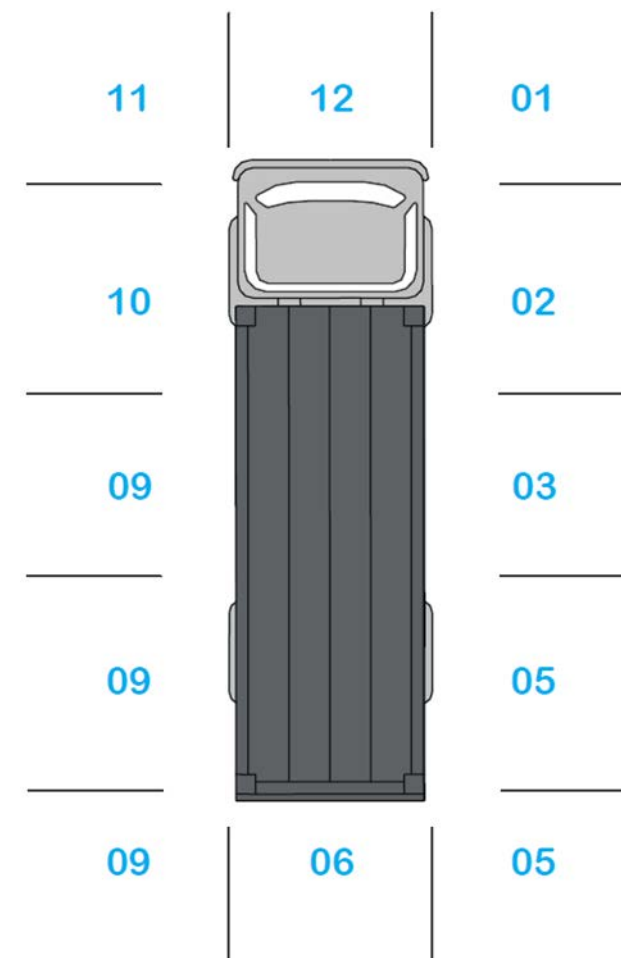
- 188 drivers (7 escaped the site)
 - 96% were men
 - 50% were age 45 – 69
 - 1% had a level of alcohol over 0,5 ‰
 - 81% were Danish citizens
 - *In road tractors 55% were Danish*
- 70% of cyclists are hit by right, front part of vehicle
 - Collision point 01, 02, 03
 - Lorries mostly hit cyclists with side of cabin (02)
 - Road tractors with right front corner (01)
 - Busses with right side (03)
